Re: Report of Geotechnical Services
Gladiator Lake Restoration in Greenacres
Gladiator Circle and Toga Way,
Greenacres, Florida
PSI Project No. 0772-727

GEOTECHNICAL ENGINEERING SERVICES
Gladiator Lake Restoration in Greenacres
Gladiator Circle and Toga Way, Greenacres, Florida

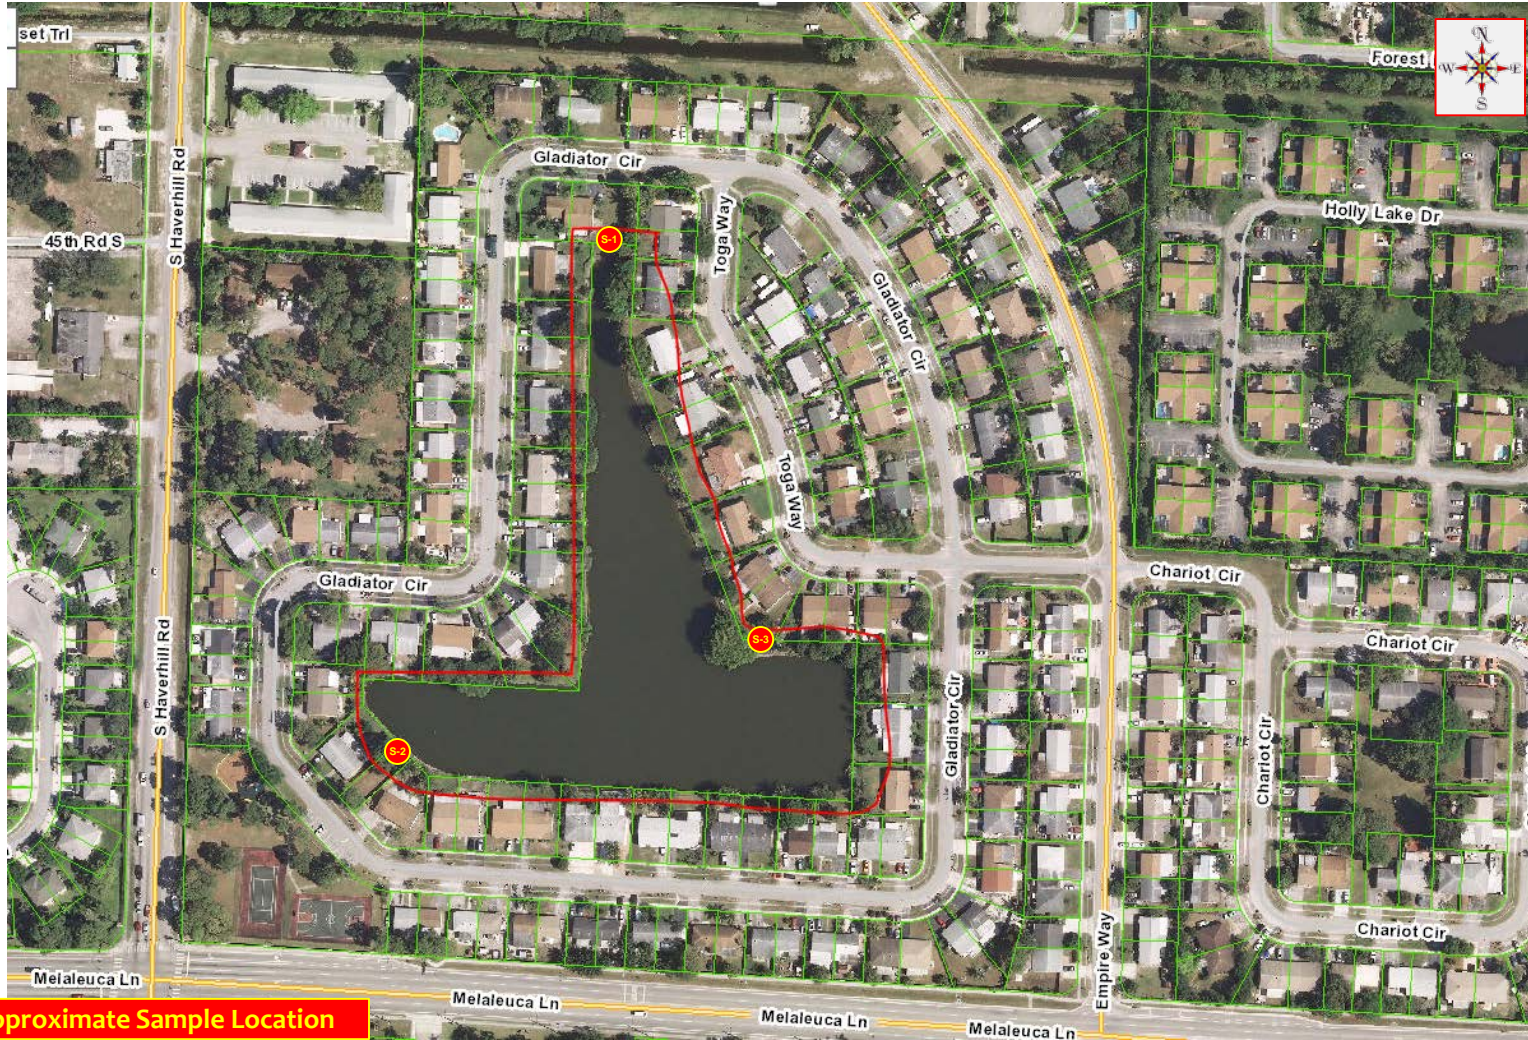
SAMPLE LOCATION PLAN

GEOTECHNICAL ENGINEERING SERVICES
Gladiator Lake Restoration in Greenacres
Gladiator Circle and Toga Way, Greenacres, Florida

Sample No.	Soil Description	USCS Classification	Angle of Repose
S-1	Poorly graded fine-grained SAND, with trace of silt, brown, moist	SP	27 ⁰
S-2	Poorly graded fine-grained SAND, with roots and organic material, with shell fragments, gray and black, moist	SP	37 ⁰
S-3	Poorly graded fine-grained SAND with trace organic material, gray, moist	SP	34 ⁰

Our experience in the vicinity suggests that the material represented by Sample 1 will be the predominate material with depth, and that the material represented by Samples 2 and 3 will primarily be found near the natural soil surface that existed prior to development. Therefore, we recommend assuming a natural angle of repose of 27⁰ for design purposes.
